## **Cathodic Protection of Hot Water Tanks at Fort Sill**

Final Report on Project AR-F-322 for FY05

L.D. Stephenson, Ashok Kumar, and James Bushman

June 2007

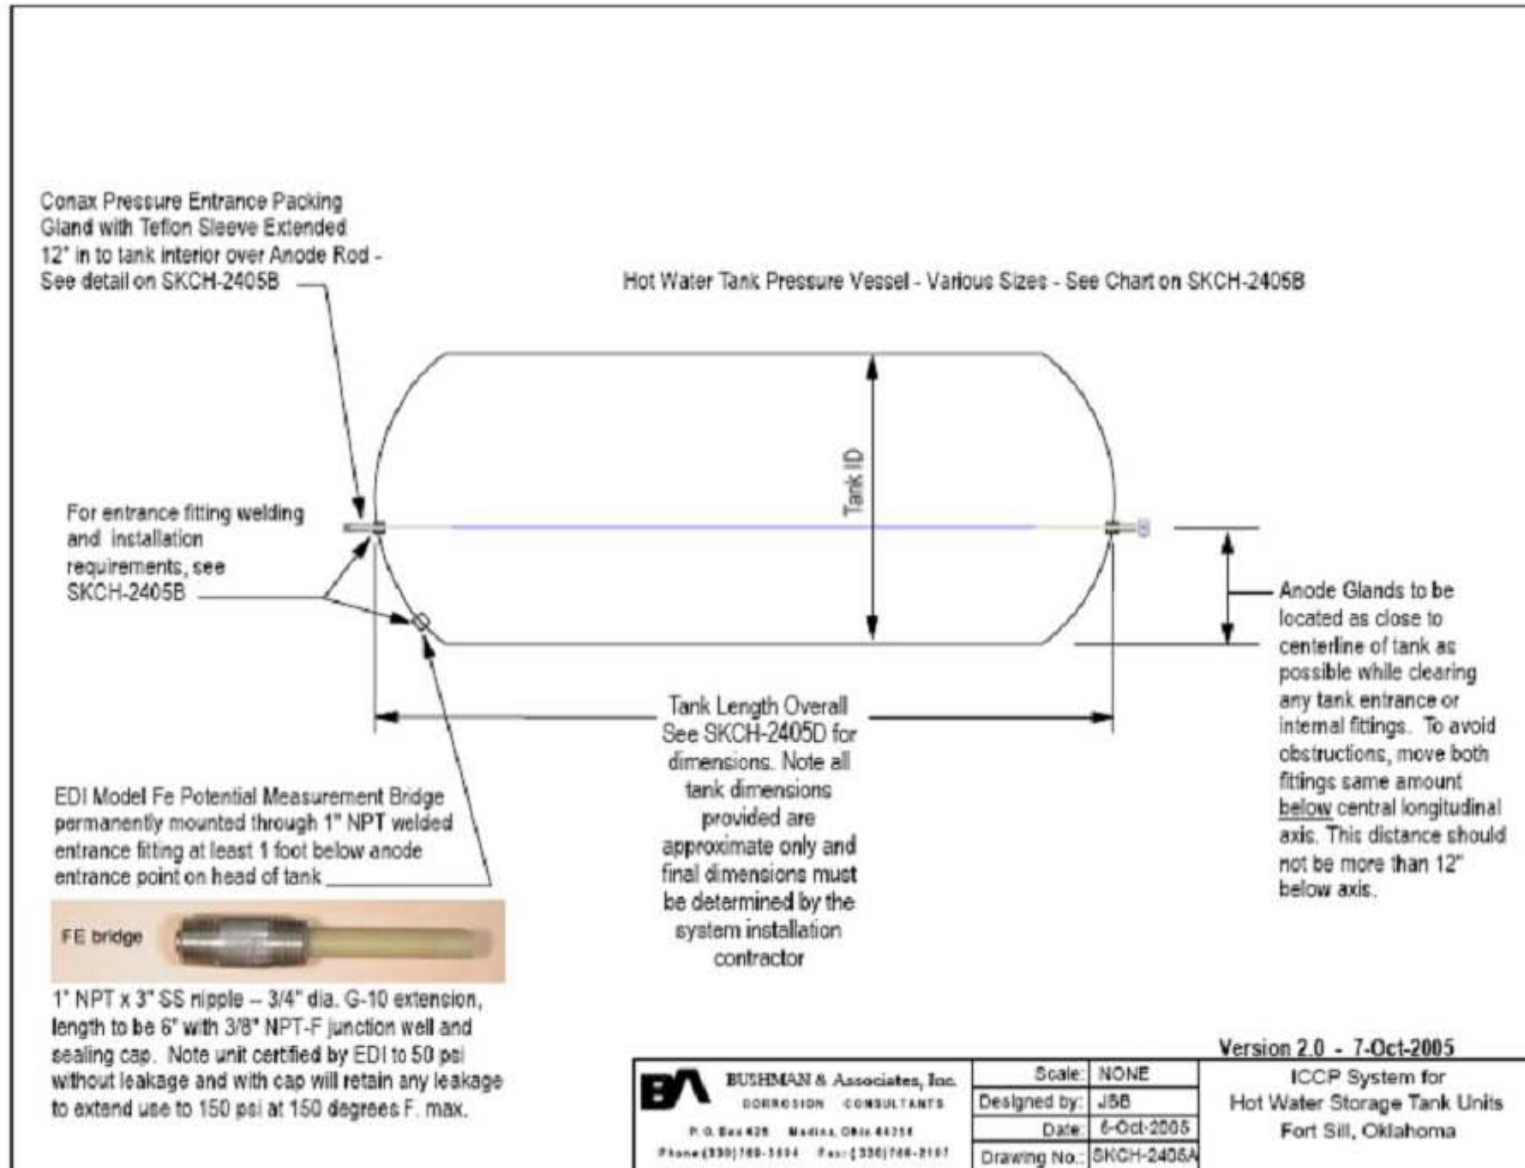
Figure 1. Schematic of ICCP system for hot water storage tanks at Fort Sill.

Following the above design calculations, the design sketches shown in Figures 1 and 2 were prepared for use by the specialized cathodic protection installation contractor.

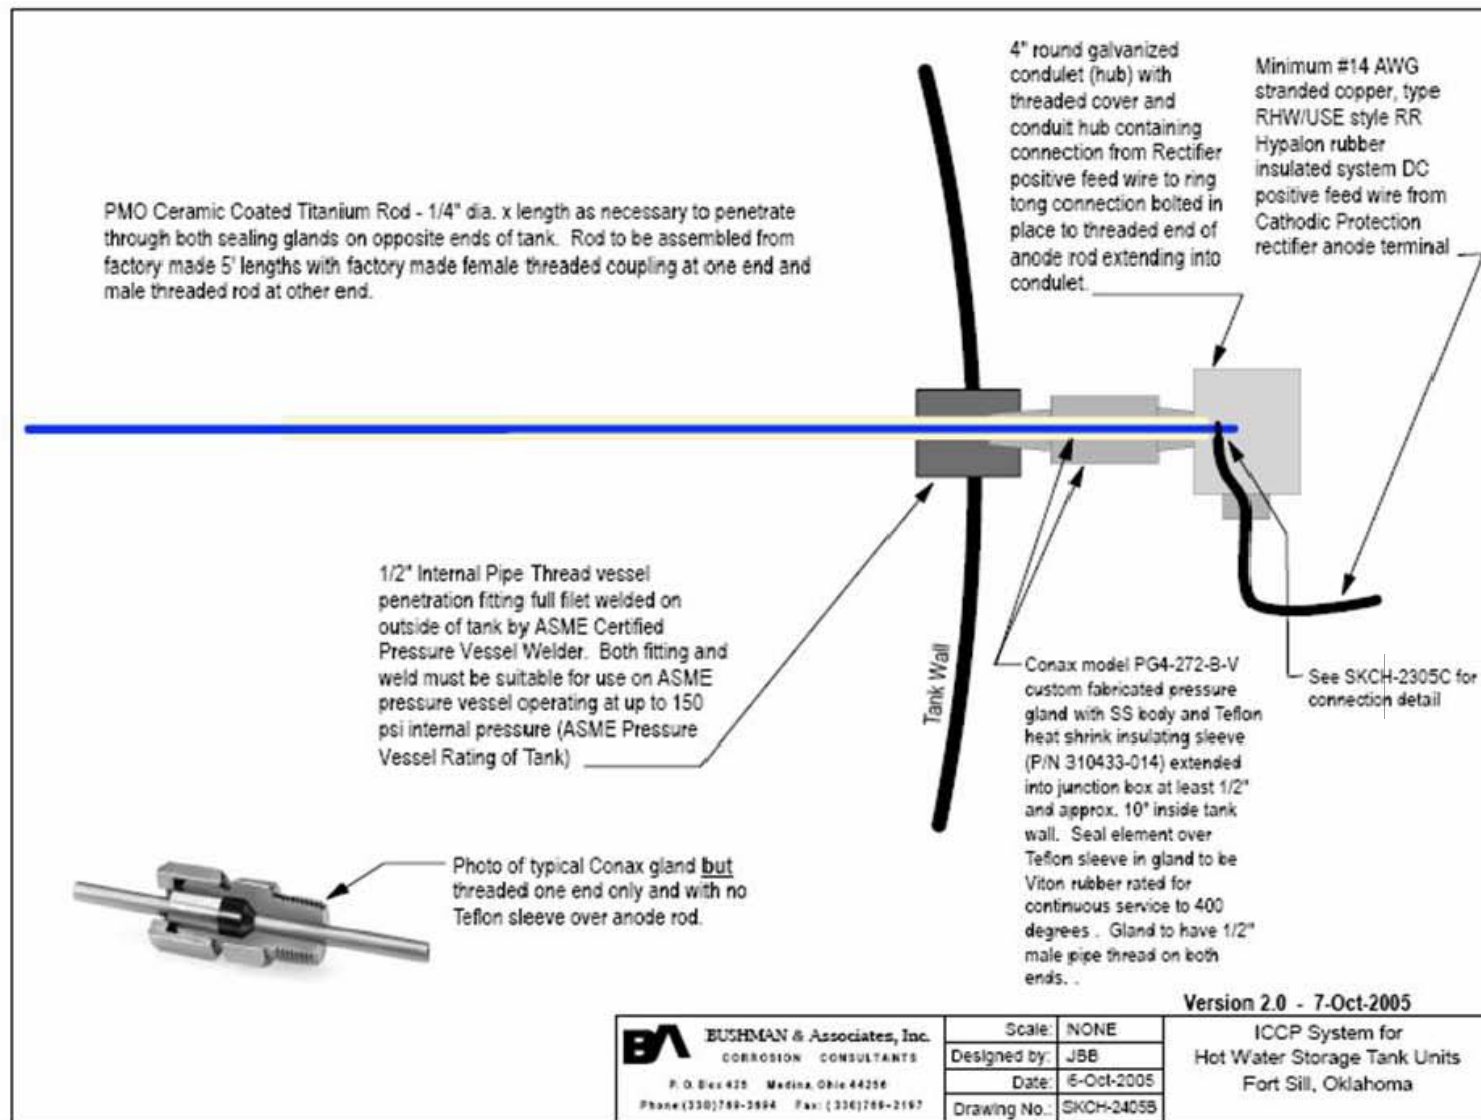
Figure 2. Schematic of ICCP system for hot water storage tanks at Fort Sill showing detail of anode installation and electrical connections.

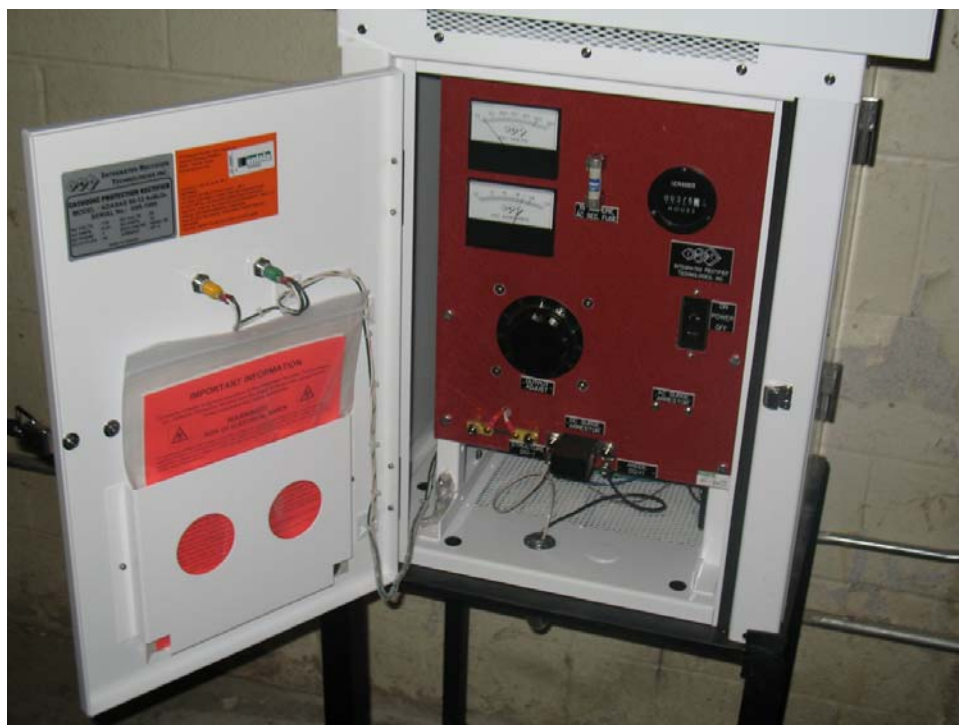
Figure 3. AC to DC Constant Voltage Rectifier/Controller Unit with Power Rheo monitor system operates red/yellow alarm light and uptime hour meter – identical unit used for all six systems.

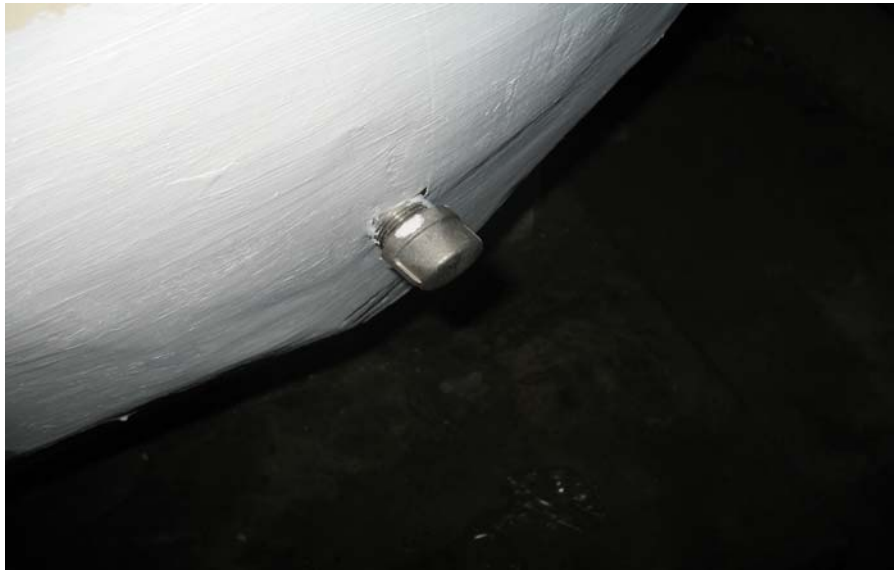
Figure 4. Reference Electrode Potential Monitoring Port with cap in place.

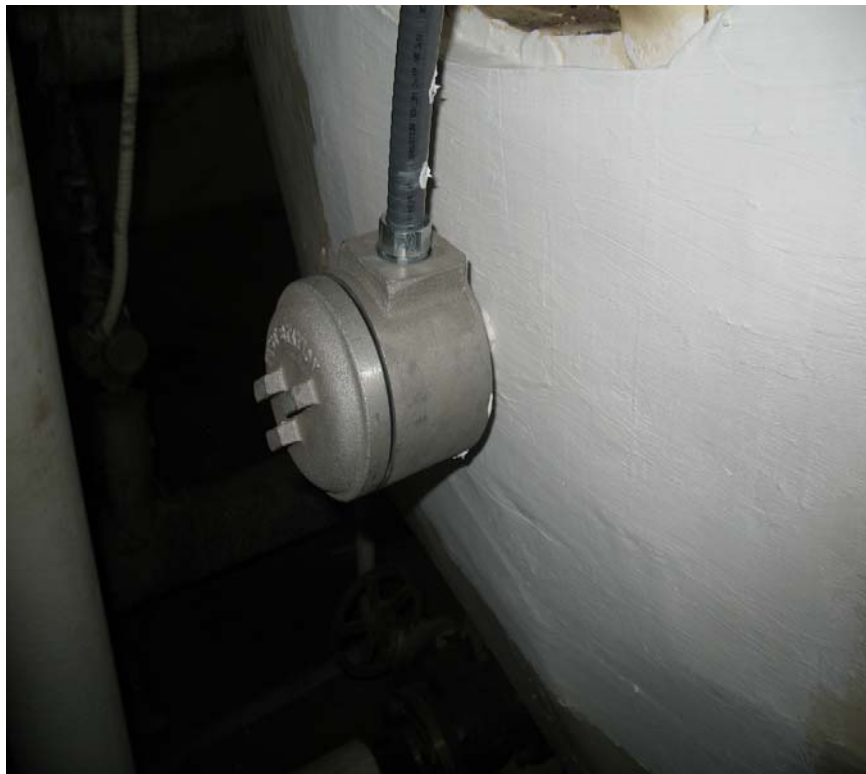
Figure 5. Precious metal oxide (ceramic) coated titanium rod entrance conduit with screw-off cover plate.

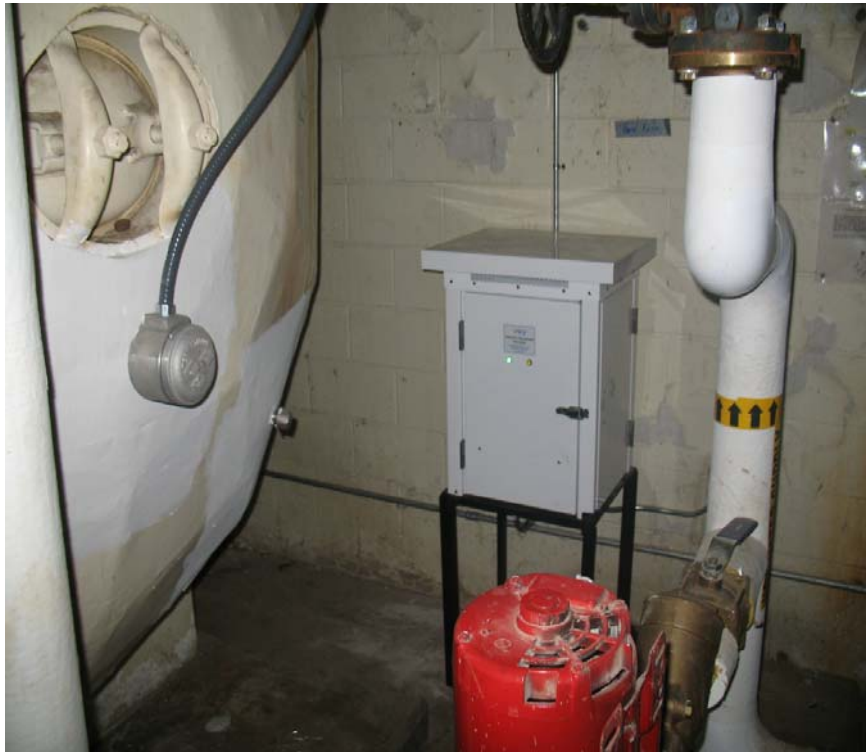
Figure 6. Typical floor rack-mounted ICCP rectifier. Note green light is on indicating unit is operating within design current limits.

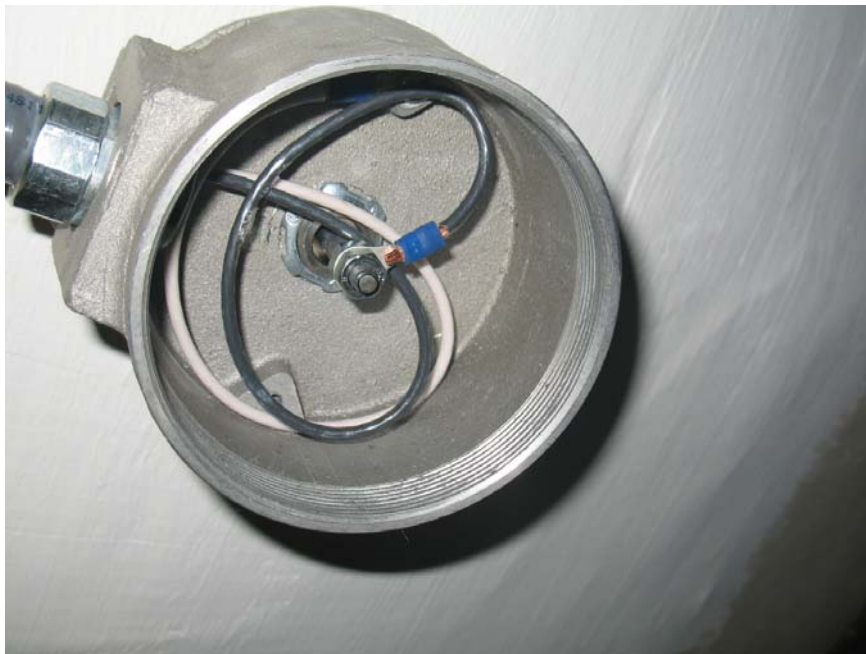
Figure 7. Anode (1/4-in. diameter) rod extending out of hot water storage tank with black insulation positive lead wire from ICCP rectifier unit attached. (Note white insulation wire is rectifier system negative ground wire).

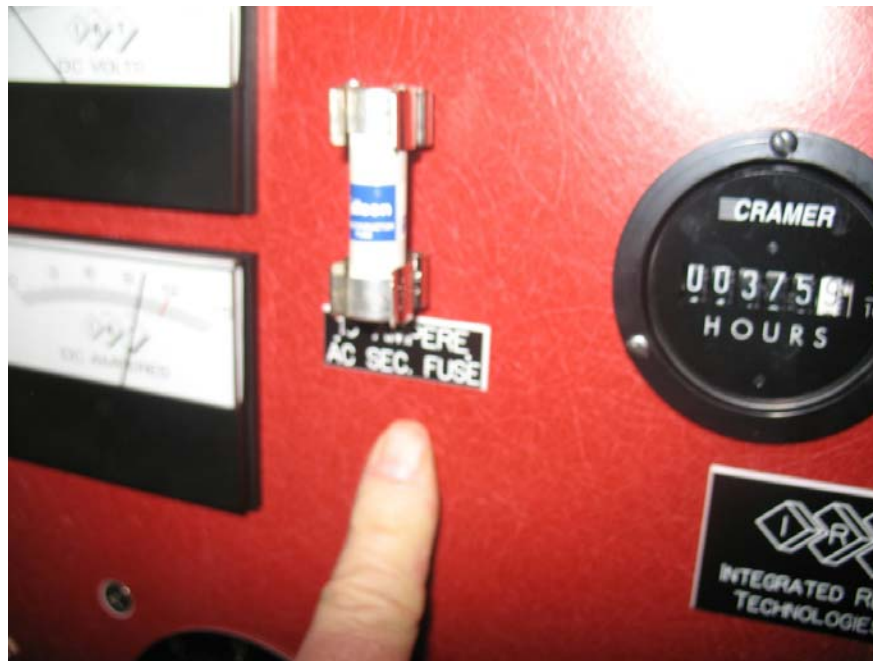
Figure 8. AC fuse on secondary side of Variac power transformer.

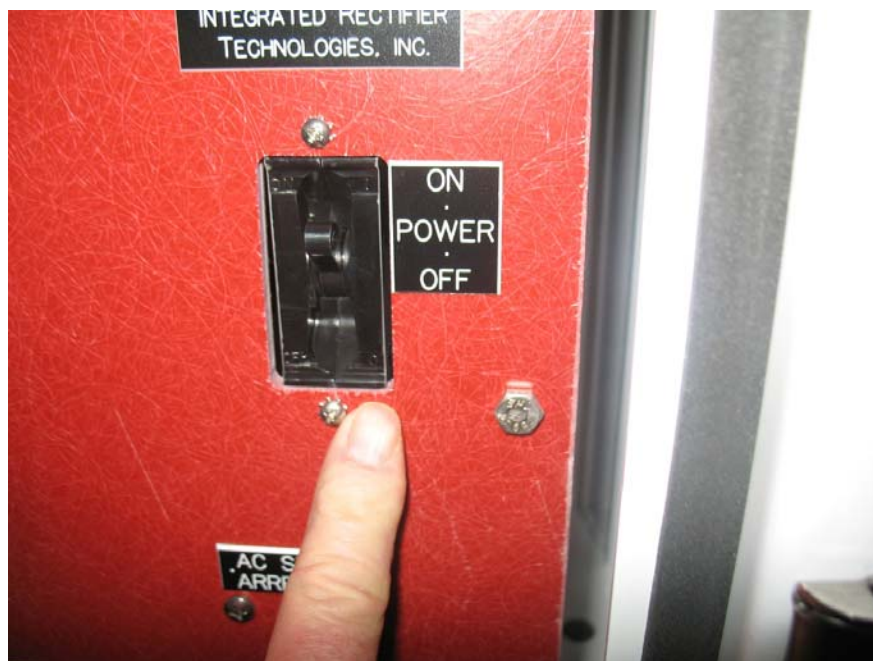
Figure 9. Input circuit breaker; use this breaker to interrupt system output when performing cathodic protection IR Drop Free potential measurements on hot water tank.

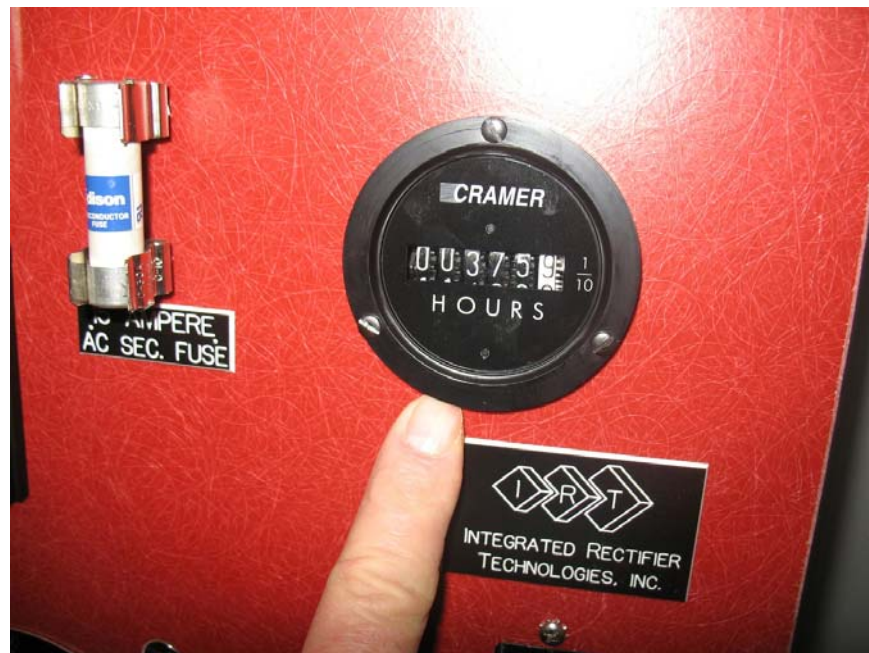
Figure 10. Digital “up-time” meter records accumulated hours system operating with green-light on (system current within minimum/maximum limits set by corrosion engineer at time of last system annual performance tests).

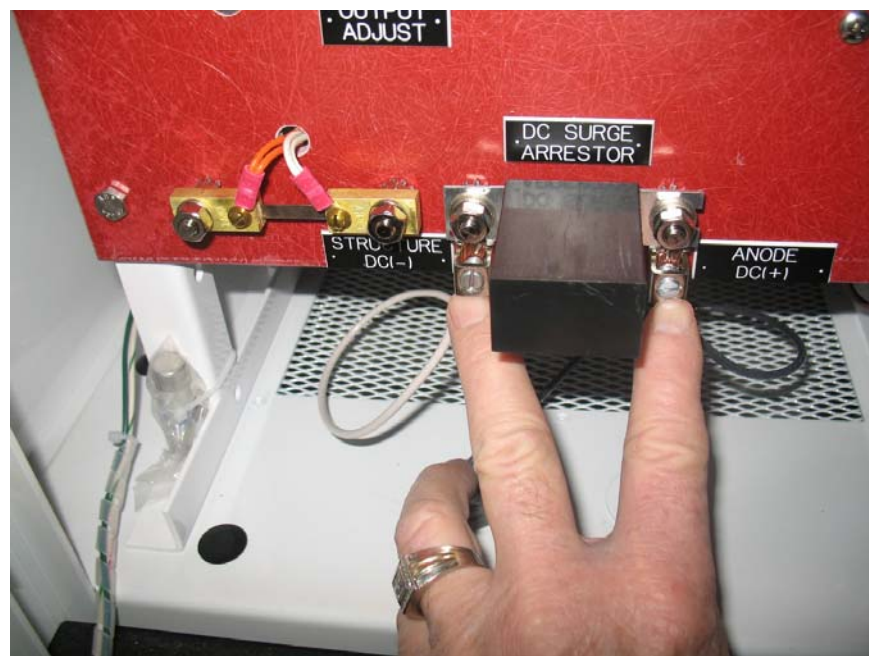
Figure 11. Positive and negative terminals for measuring system DC voltage output- note positive (+) anode terminal is on right and system negative (-) terminal is on left.

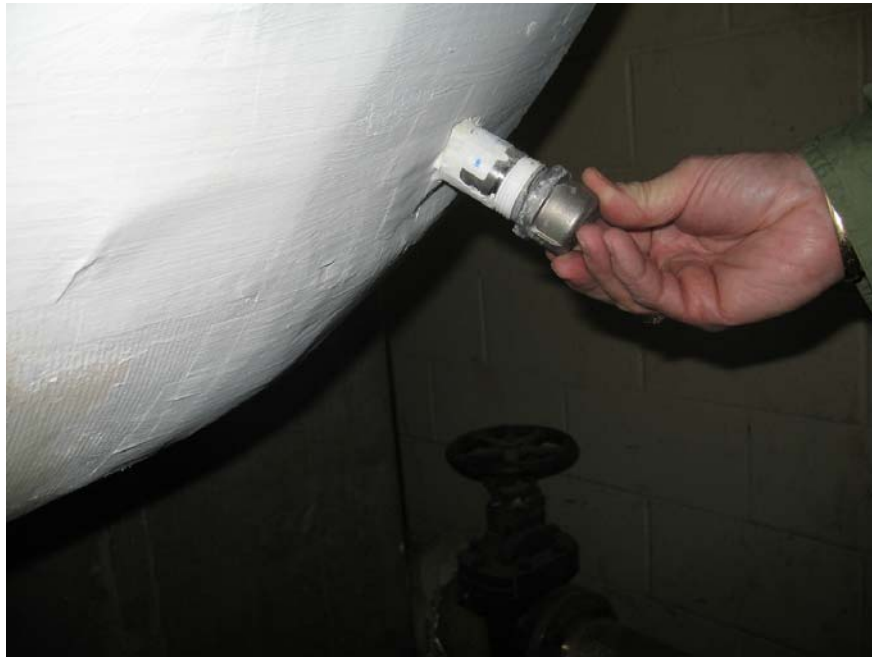
Figure 12. Outer cap on port must first be removed with pliers or wrench.

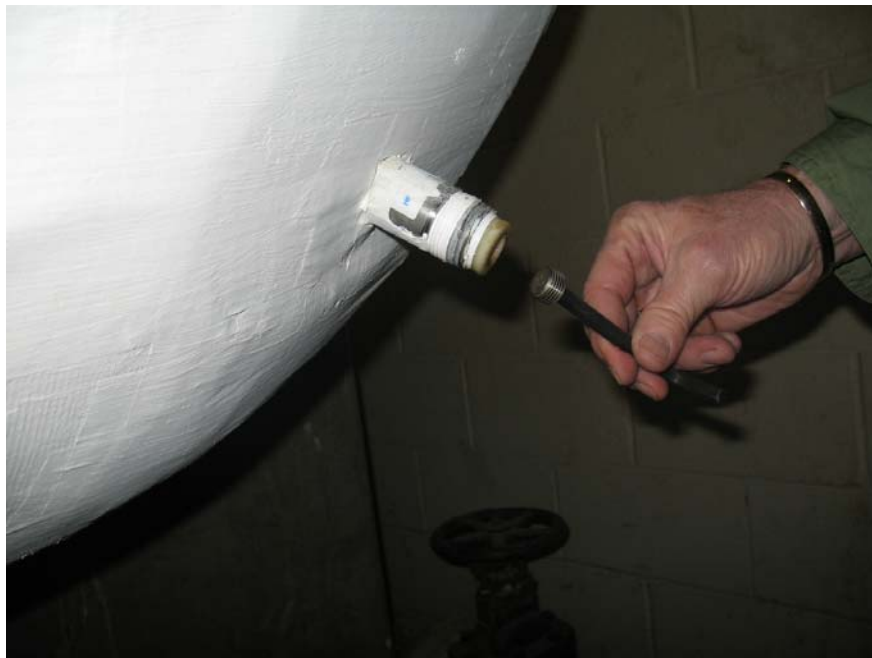
Figure 13. Once cap is removed, inner plug on access port must be removed using hex key stored inside rectifier manual plastic jacket.

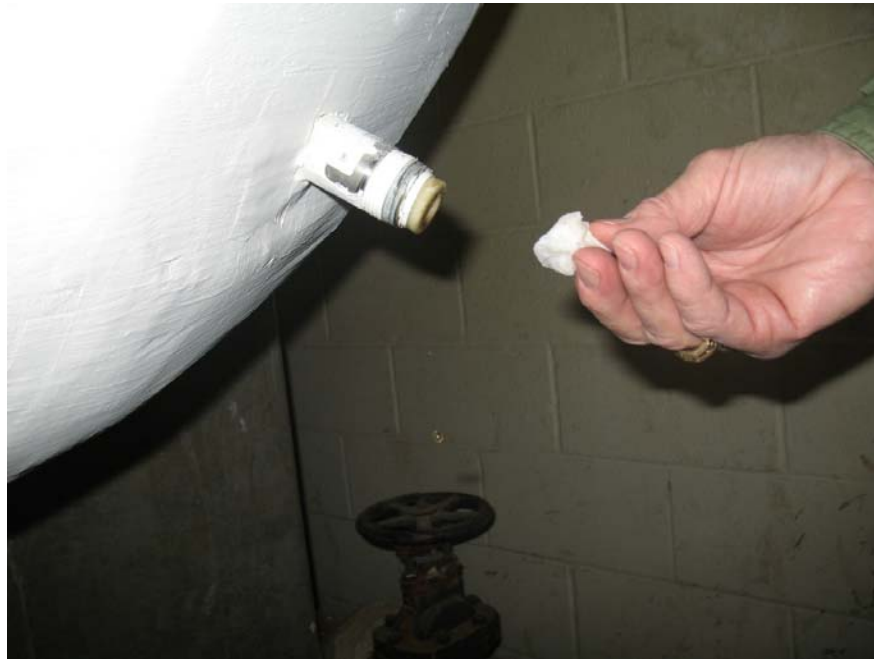
Figure 14. To facilitate contracting the osmotic conductor side of the port, cotton or paper “wadding” is moistened and pushed down inside the port to the tip of a standard reference electrode placed in contact with the remaining portion of the wadding sticking out of the port.

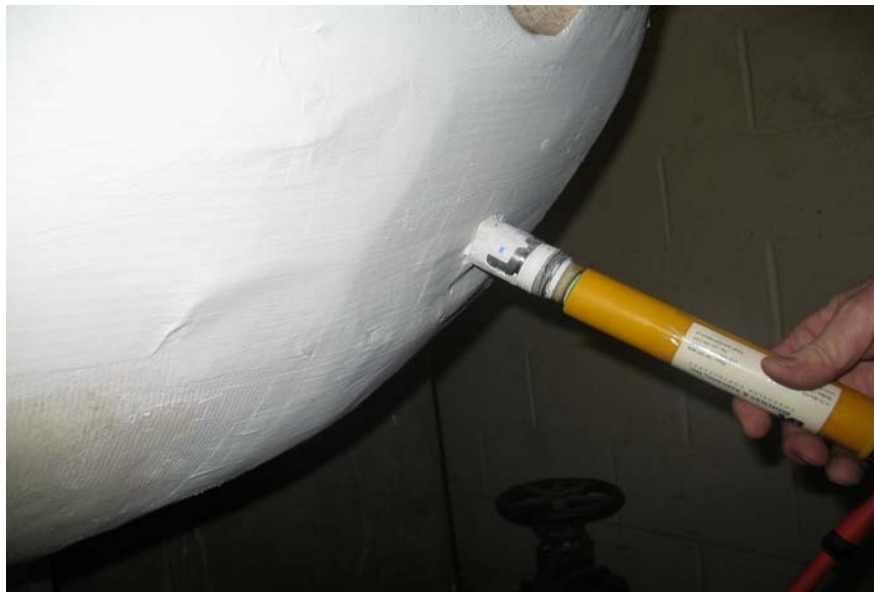
Figure 15. After carefully wiping dry the exterior of the port a calibrated Cu-CuSO<sub>4</sub> electrode is placed in contact with the moist wadding.

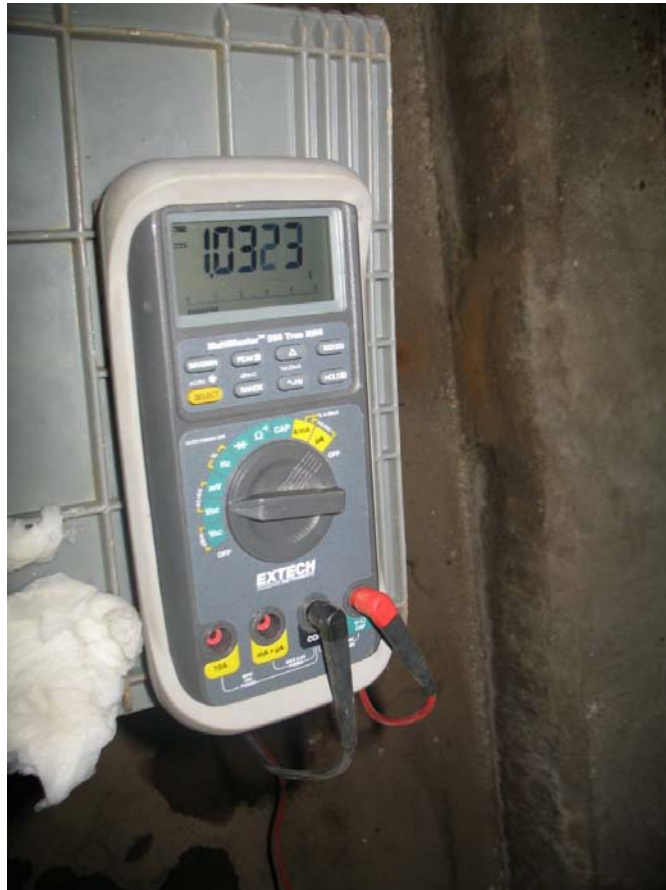
Figure 16. The DC voltmeter positive lead is connected to the reference electrode and the negative is connected to the structure.

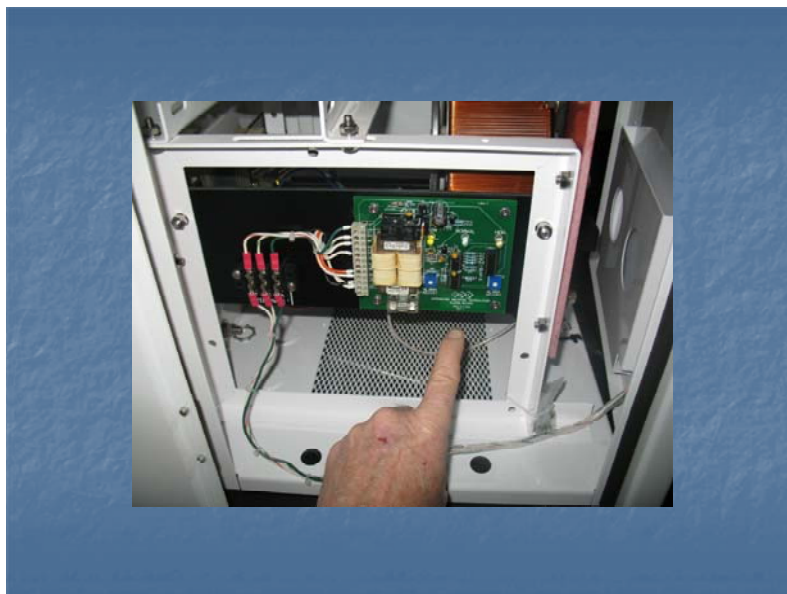
Figure 17. Current output alarm circuit control and adjustment panel.

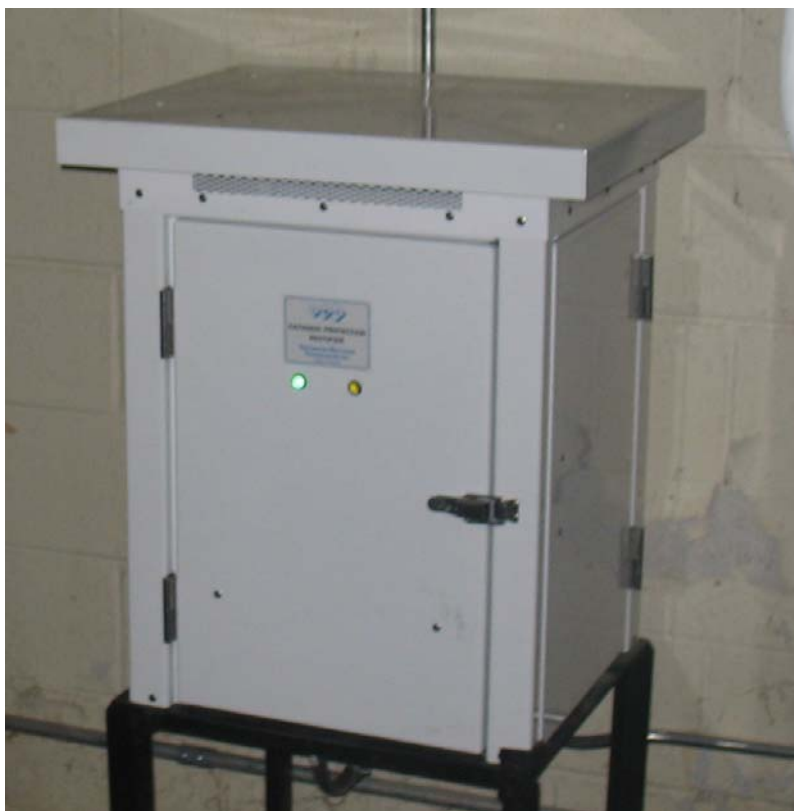
Figure 18. Note green light is lit indicating that system DC current output is within the range set at the last detailed annual corrosion / cathodic protection system effectiveness check-out of the system.

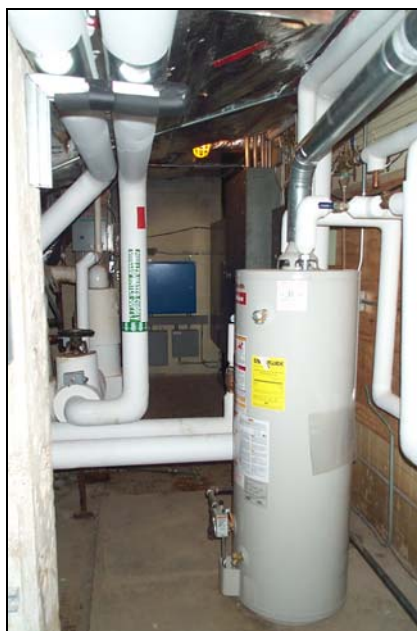
Figure 19. Typical 37 gallon replacement tank with glass linings and sacrificial anodes installed at Fort Sill.

To provide corrosion protection, all internal surfaces exposed to water were factory glass-lined using a National Sanitation Foundation (NSF) approved glass lining compound. In addition, the tanks had factory installed sacrificial magnesium anodes to protect any internal surfaces that may be exposed to the corrosive environment if a holiday developed in the coating.

The “glass” lining is actually a type of porcelain enamel. The interior of the tank is sprayed with a porcelain enamel frit and then baked (heated to a temperature between 1400 and 1600 °F), which melts the frit and bonds it to the steel tank. The tank is then cooled. All glass-lined tanks require a magnesium anode, since the porcelain enamel has tiny pinholes throughout. The magnesium anode acts sacrificially to these pinholes in the lining and prevents corrosion.

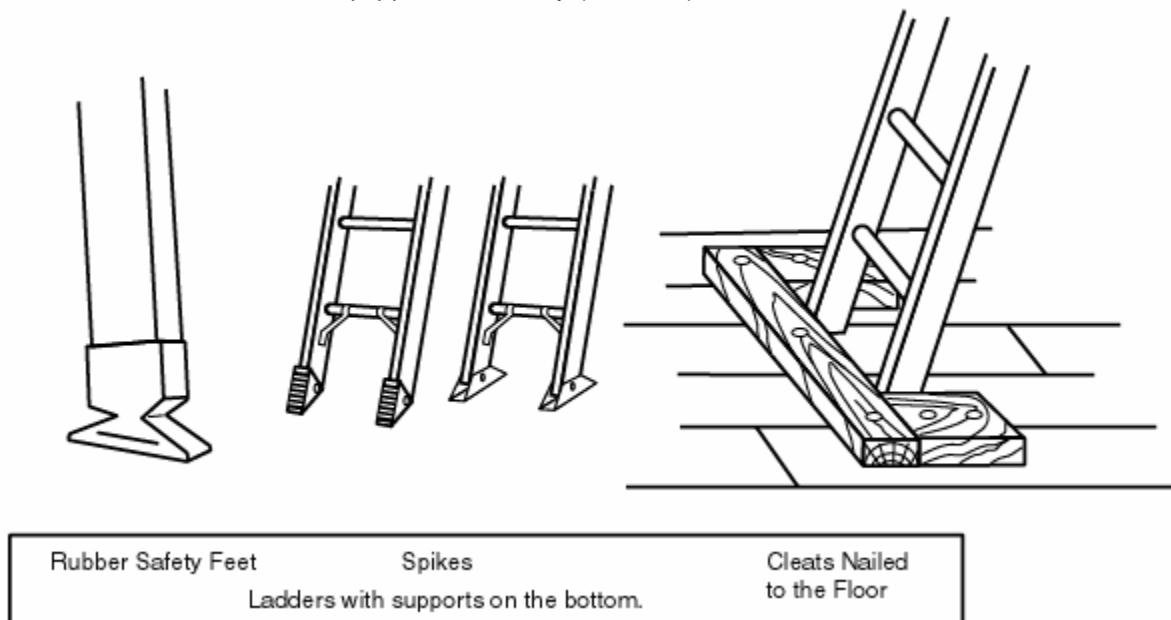
- All ladders must be equipped with safety (non-skid) feet.

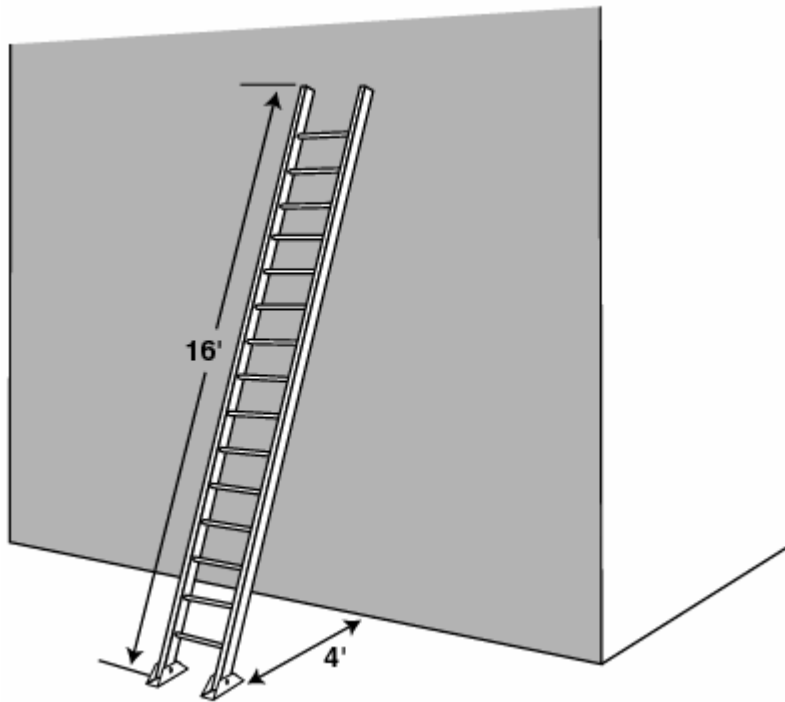
- Portable ladders must be used at such a pitch that the horizontal distance from the top support to the foot of the ladder is about one-quarter of the working length of the ladder.

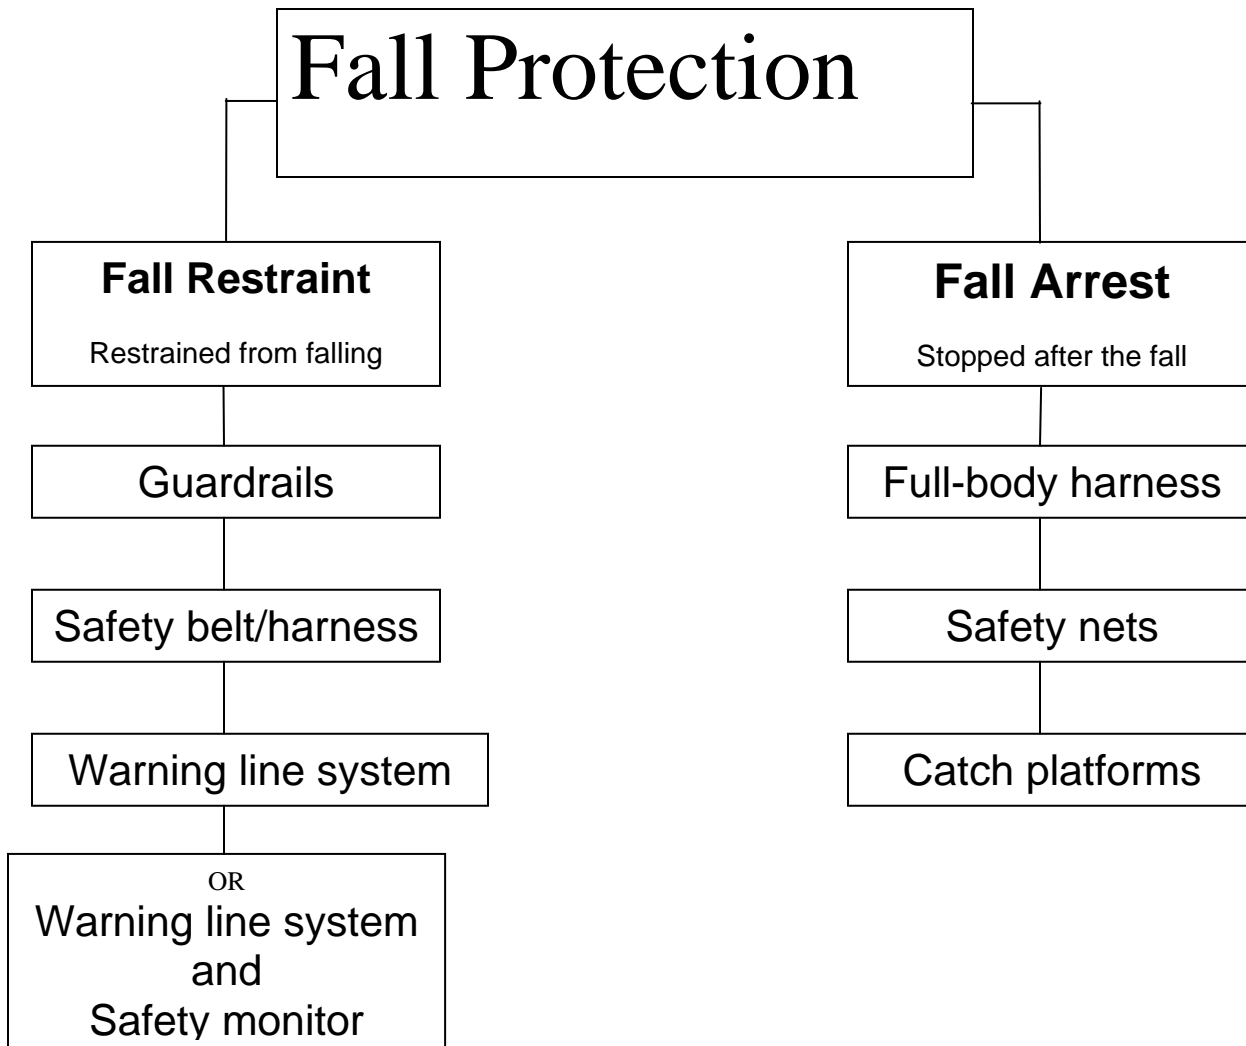
Fall protection will be provided either through the use of a fall arrest system or a fall restraint system as shown below and thoroughly described in the fall protection work plan available on site for review.

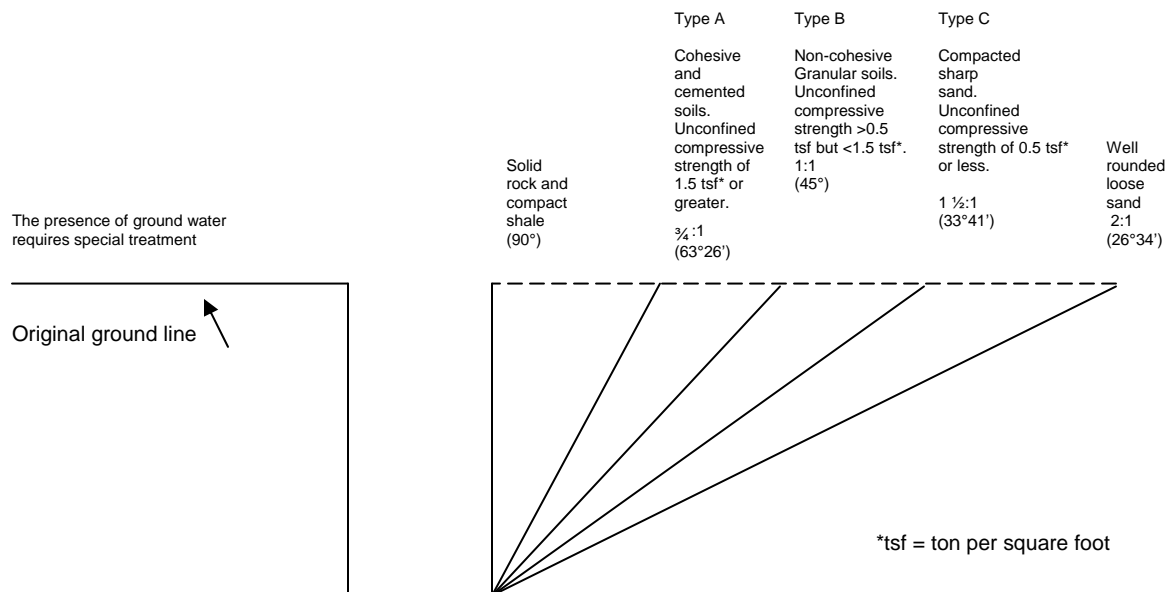
For sloping of sides of excavations

1. The determination of the angle of repose and design of the supporting system shall be based on careful evaluation of pertinent factors such as:
2. Depth and/or cut/soils.
3. Possible variation in water content of the material while excavation is open.
4. Anticipated changes in materials from exposure to air, sun, water or freezing.
5. Loading imposed by structures, equipment, overlaying material or stored material.
6. Vibration from equipment, blasting, traffic or other sources.

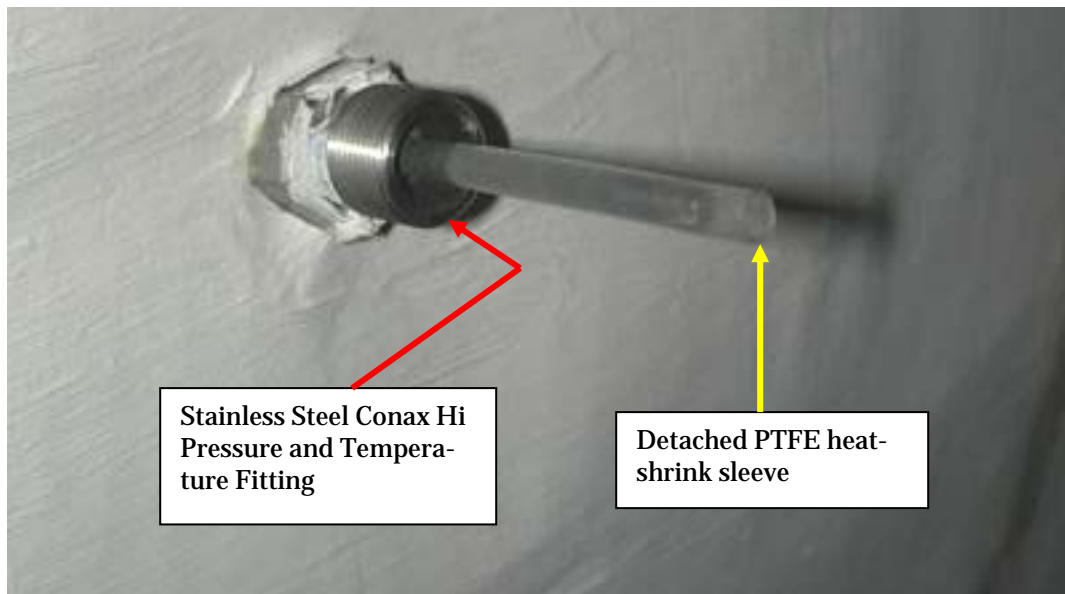
Figure 1. Front end of fitting in building 5955 tank showing detached PTFE heat-shrink sleeve. A partial short possibly occurred near the precision fit stainless steel bushing in the Conax fitting, overheating the PTFE sleeve to cause brittle cracking during the heat shrink process.

**Summary:** The ICCP system in the Hot Water Storage Tank in Building 5955 has been fully repaired and is now operating as designed. It should be understood that, due to the nature of the “partial” or “near” short, protection was being maintained but the system efficiency was lower than desired. The repairs have corrected this deficiency. The other systems are

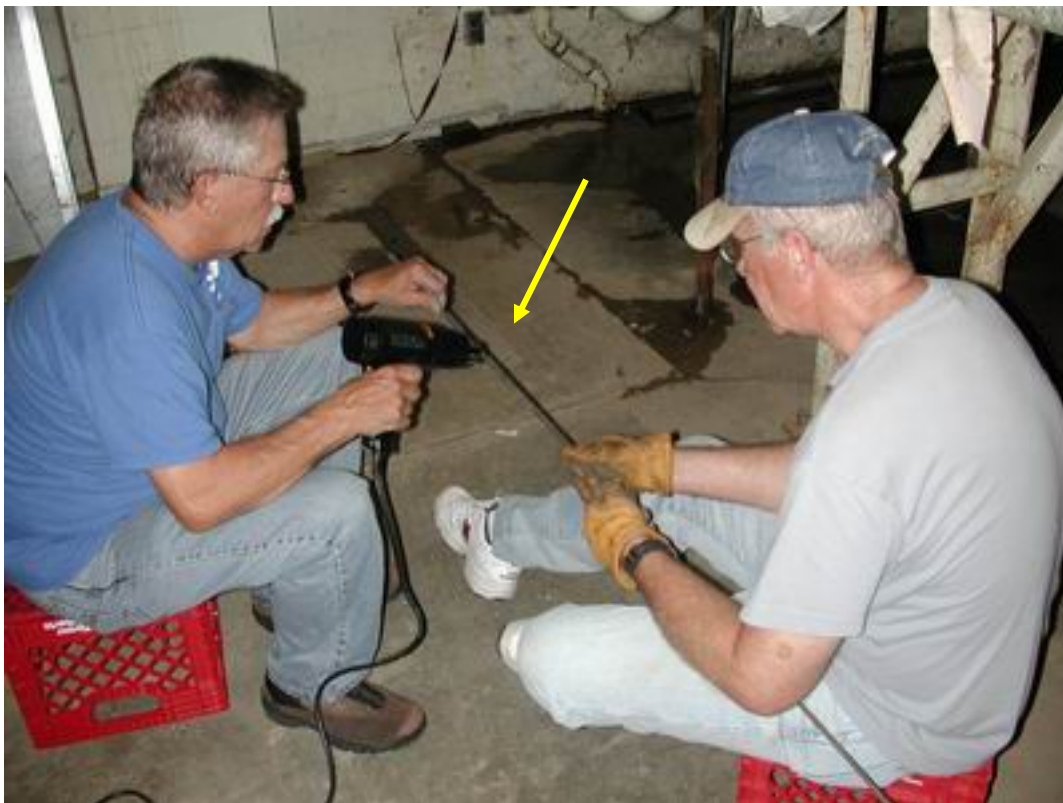
Figure 2. Personnel shrinking new PTFE Sleeve onto one end of the anode using heat gun.
